## **IN DEPTH: Shattered glass: what causes panes to fall off buildings**

Two engineers explain what could be behind recent incidents in Toronto, Montreal, Austin

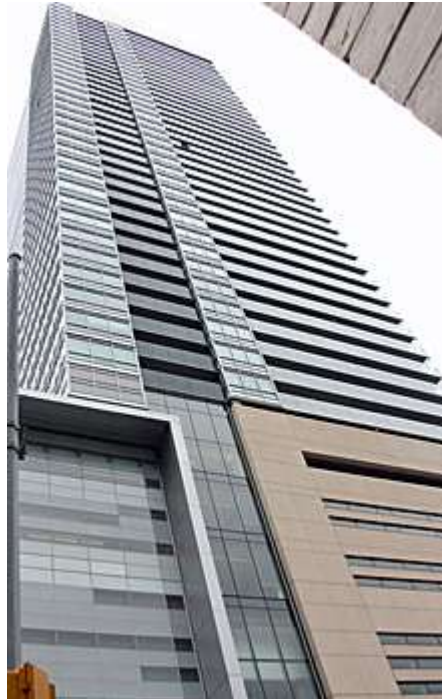
*A missing pane of glass can be seen about halfway up the Festival Tower at King and John streets in Toronto. The piece of glass fell from a 27th-floor balcony on Tuesday night. Andrew Lupton/CBC*

The incidents happened at the Festival Tower above the TIFF Bell Lightbox, the new headquarters of the Toronto International Film Festival that opened only last year; and at one of two highrises that make up the Murano complex on Grosvenor Street near Bay Street.

The developer of the Festival Tower, the Daniels Corporation, said Wednesday the company did not yet know what caused the glass to break and would be erecting scaffolding on the sidewalk below while it investigated further. Daniels did say the glass that fell from the same building last month did so because of pressure exerted on it by the expansion of a metal balcony railing in the heat.

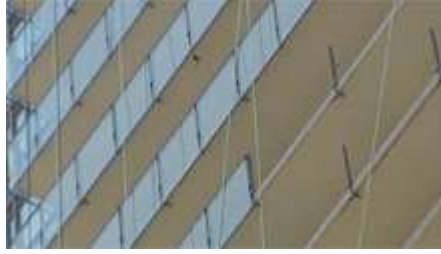
At the Murano tower, the glass that fell was part of balcony partitions installed in 2009, at least eight of which have shattered since December 2010. They were made by a company that has since gone out of business, according to the developer, Lanterra Developments.

*A screen shot of some of the balconies under repair at the Murano condominium complex on Grosvenor Street in Toronto, where several panes of glass have fallen from the structure.*

After two panes fell in late July, the city ordered Lanterra to remove the balcony glass from the building because the situation was deemed unsafe for people in and around the structure, the Toronto Star reported.

Lanterra Developments doesn't have the option of waiting for that kind of assessment. It has already begun replacing the glass balconies at its Grosvenor tower and said the process will likely take until October and cost millions of dollars.

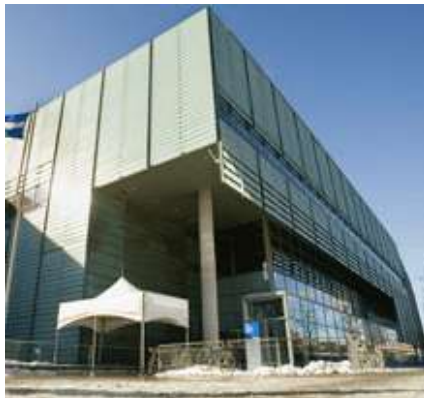
The panes that fell from the Toronto buildings were tempered glass, as are the panes that have been falling off the Bibliothèque et Archives nationales du Québec in Montreal. The library has had 15 of the 6,200 decorative, frosted-glass panels that cover its façade shatter to date, the most recent one in August 2010.

An independent assessment of the glass problem commissioned by the library found that 30 per cent of the panes on the building do not meet Canadian standards for glass treatment. It suggested the library have the glass re-treated.

*The Bibliothèque et Archives nationales du Québec on Montreal's Berri Street has been shedding its frosted glass panels almost since it opened in 2005. (Paul Chiasson/Canadian Press)*

The engineering consultants who carried out the assessment concluded that shattering could occur because of a combination of faulty treatment, fractures within the glass and too tight mounting of the glass onto the façade, which didn't allow for temperature-related expansion and contraction.

In the case of the Montreal library, the building contractor, Pomerleau Inc., contested the findings of the library's consultants and, in the end, the library chose to simply replace the 15 broken panes with the same type of glass, not do a new treatment.

It also installed a permanent buffer zone around the building made up of shrubs, bushes, plants and 1.8-metre-wide aluminum and galvanized-steel awnings.
